# Manhole Inspection Summary

Manhole # S19A\_\_016MH

Insp Date: **10/24/07 12:01 PM**

**Location** Address: **703 PAYSON-APPLETON**

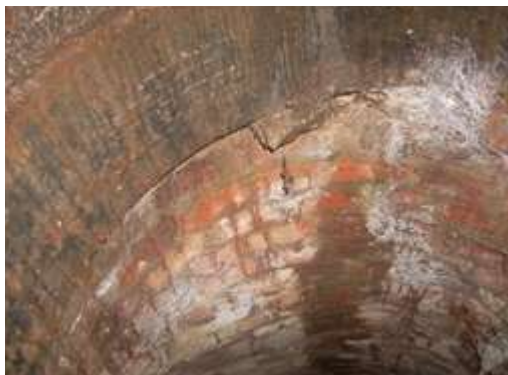
Defect 5

Infiltration: ☐ None ☒ **Joint** ☐ Cracks ☐ Mortar ☐ Roots ☐ Wall

JOINT INFILTRATION

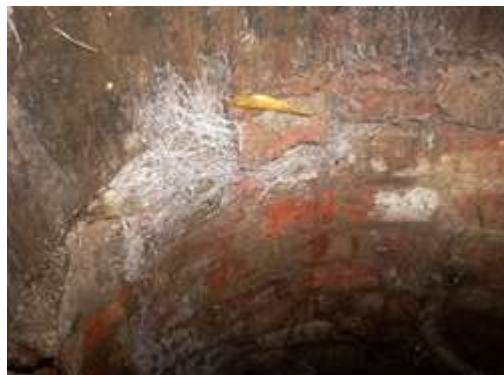
Defect 4

Condition: ☐ Sound ☐ Cracked ☐ Root Intrusion ☒ **Loose Brick** ☒ **Deteriorated**

LOOSE CORBEL BRICKS

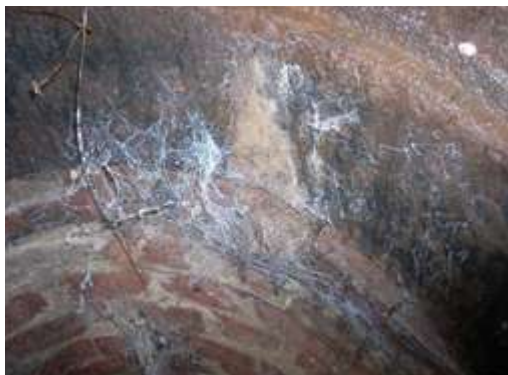
Defect 3

DETERIORATED CHIMNEY

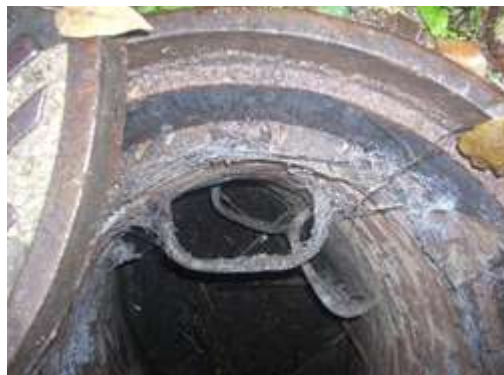
Defect 2

Offset: **1** (in.)

FRAME OFFSET

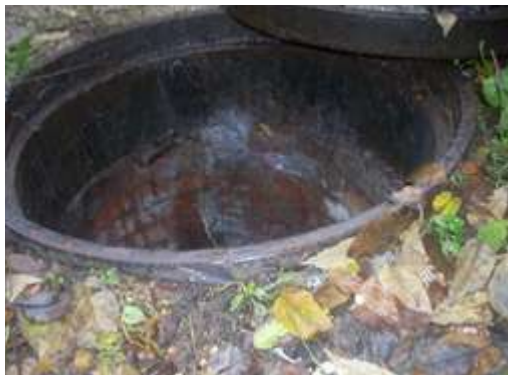
### Defect 1

Diameter: **24** (in.) Length: (in.) Dist A/B Grade: **1** (in.)

GRADE ADJUSTMENT

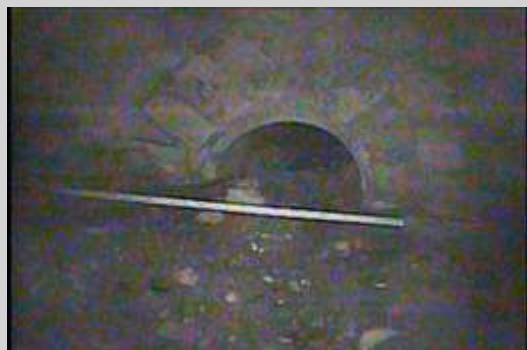
12 O'Clock Outflow

8 in. Circular Gravity Sewer  
Pipe Out @ 12 O'Clock

Deposits: ☐ None ☒ **Mud** ☐ Sludge ☒ **Debris** ☐ Grease

Silt Depth: **2** (in.) Deposits Extent: **Medium**
